UNITED STATES ENVIRONMENTAL PROTECTION AGENCY

SUBJECT: Immediate Removal Request for the Shaffer
Equipment Site, Fayette County, Minden,
West Virginia

FROM: Robert E. Caron, On-Scene Coordinator
Emergency Response Section (3HW22)

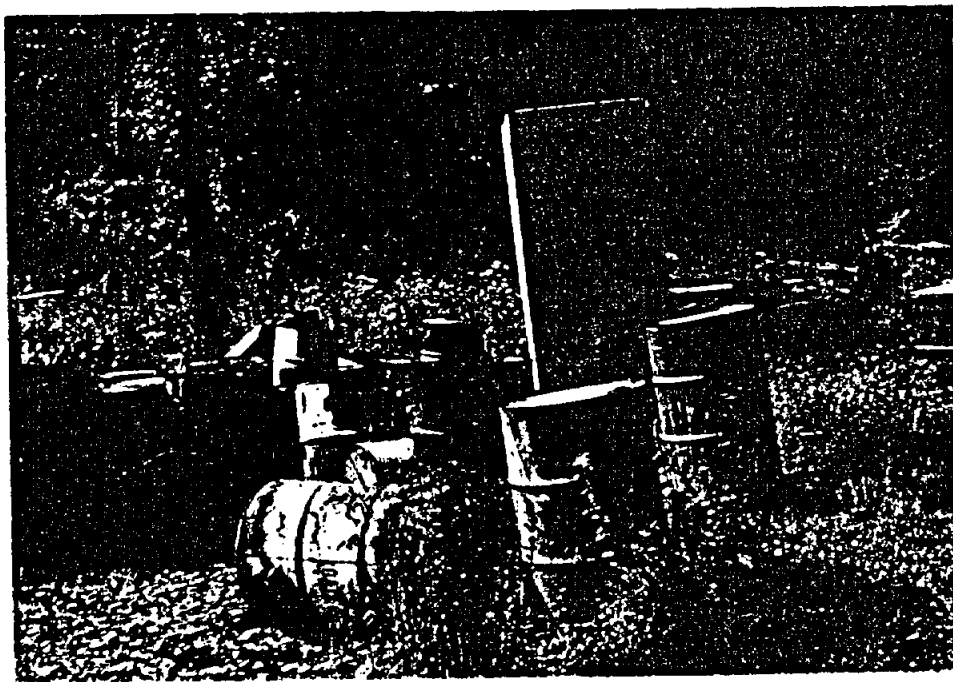
DRUM STORAGE

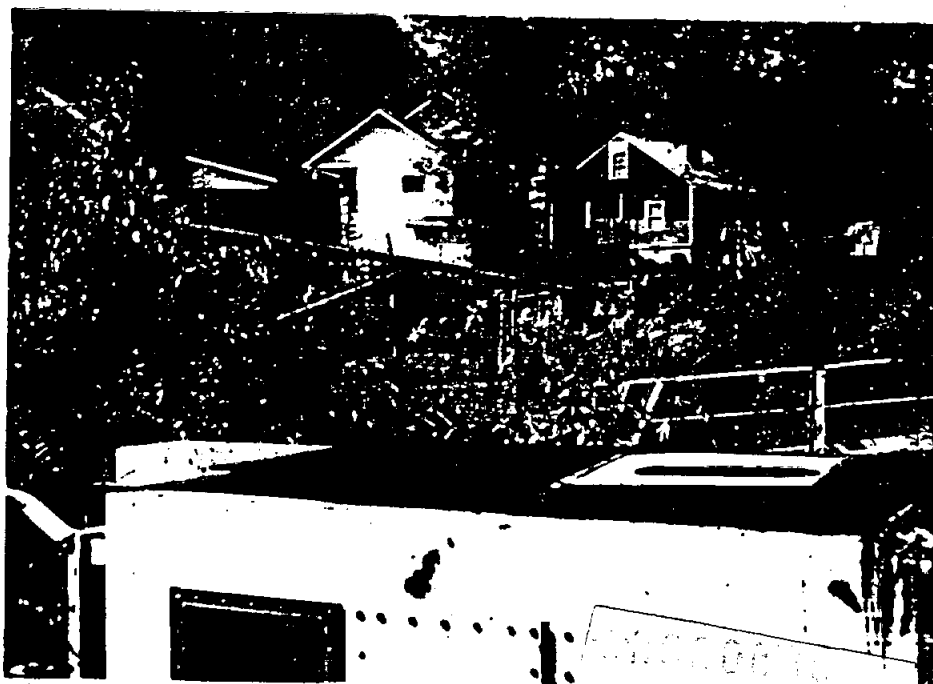
PROXIMITY OF RESIDENCES
